APPLICATIONS OF THE SHOCK PULSE TECHNIQUES TO HELICOPTER DIAGNOSTICS

Timothy C. Mayer
Edward F. Covill
John A. George
J. Thomas Harrington

24 February 1975

Final Report.

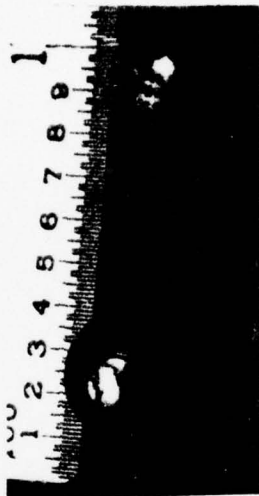
Fig. 4.3

When viewing the pictorial evidence (Fig. 4.3), it is relatively simple to correlate damage with shock emissions on the single bearing fixture. By comparing the graph of new or "O" time replacement, it is possible to see the appearance of damage vs undamaged components.

Hanger Bearing
P/N A20-44891
A/C 65-9519

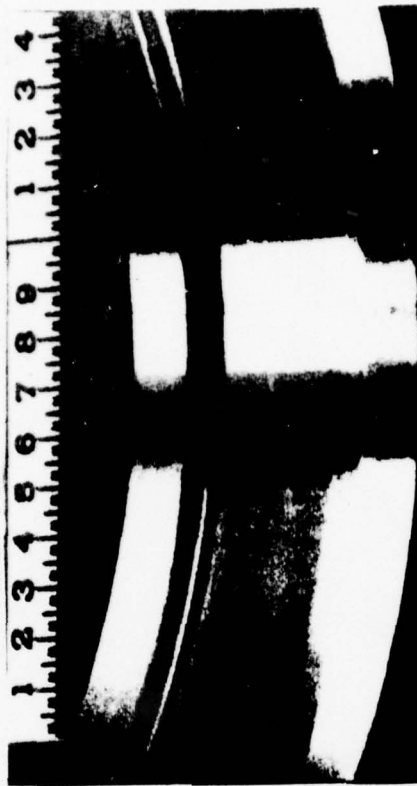
Roller Bearing
S/N 23475
Outer Race

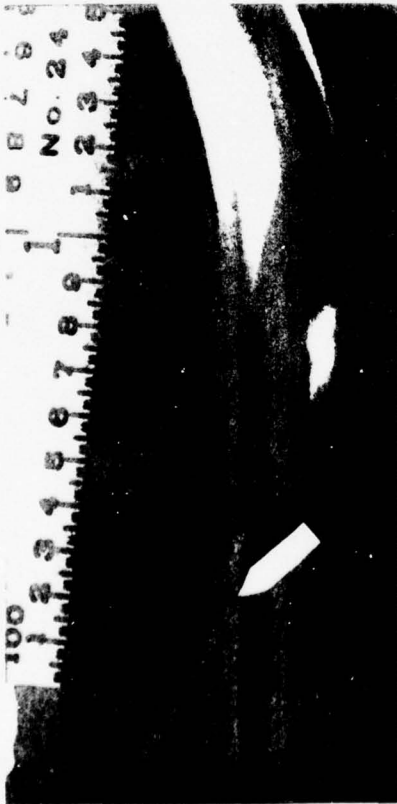
Duplex Ball Bearing
S/N 8199-H-2
Outer Race

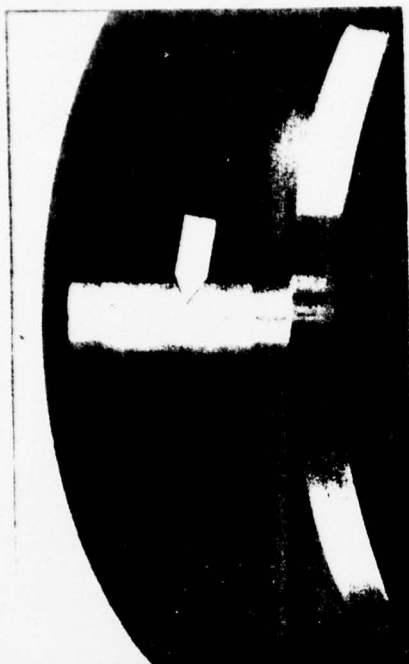
Roller Bearing
S/N 21020
Inner Race

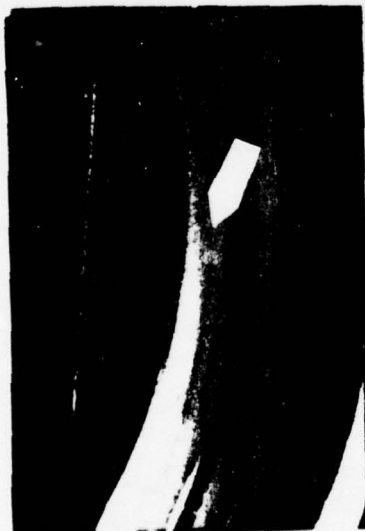
Duplex Ball Bearing
S/N 8112-H-1
Outer Race
